**Flood Control Project Maintenance**  
**Levee Inspections**

**Fall 2012 Levee Maintenance Deficiency Summary Report**

**Reclamation District No. 1001 Nicolaus**

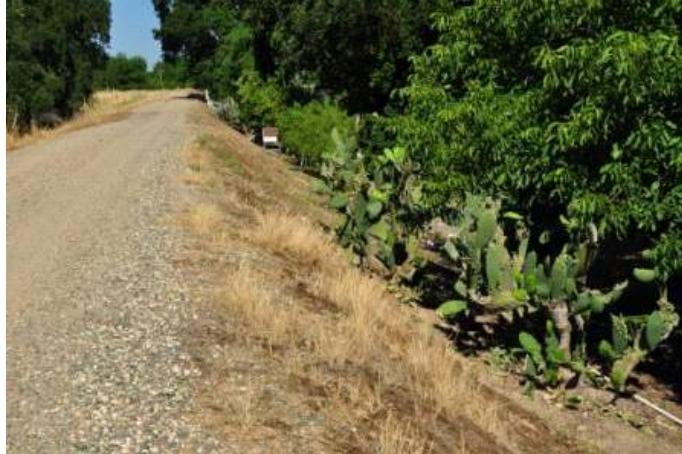
Levee Mile Report Line	8
Start Levee Mile	3.16
End Levee Mile	3.22
Location	Land Side
Category	Earthen Levee
Item	Vegetation
RD 1001 Unit 1 - Landscaping	
cathom_f_20120912_096.JPG

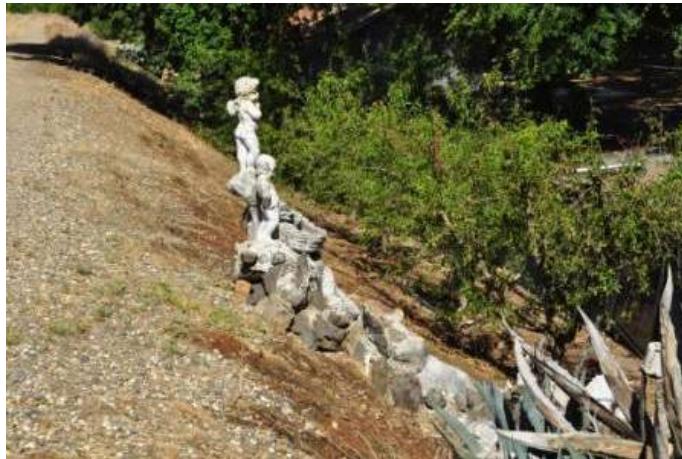
Levee Mile Report Line	8
Start Levee Mile	3.16
End Levee Mile	3.22
Location	Land Side
Category	Earthen Levee
Item	Vegetation
RD 1001 Unit 1 - L/S - Landscaping	
cathom_f_20120912_097.JPG

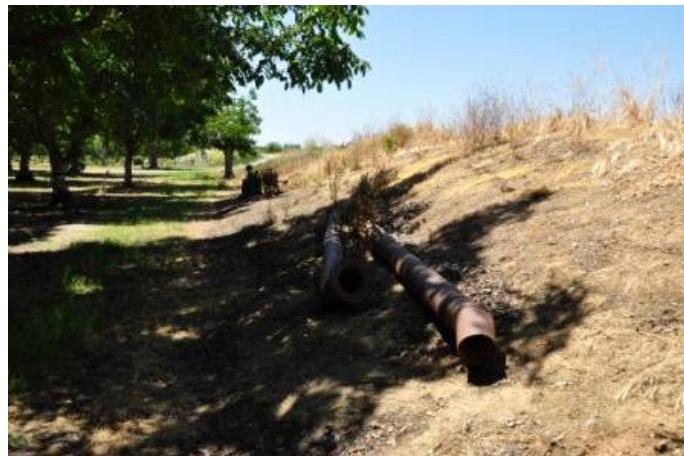
Levee Mile Report Line	4
Start Levee Mile	0.54
End Levee Mile	0.54
Location	Land Side
Category	Earthen Levee
Item	Encroachments
RD 1001 Unit 2 - L/S - Equipment, Old pipes and pump	
cathom_f_20120912_104.JPG

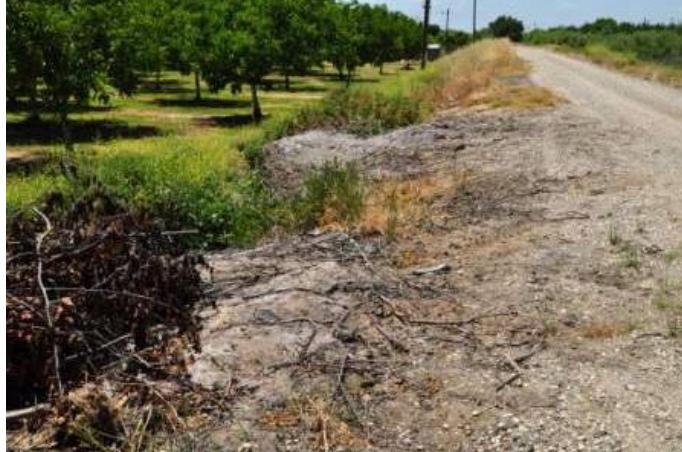
Levee Mile Report Line	5
Start Levee Mile	0.58
End Levee Mile	0.58
Location	Land Side
Category	Earthen Levee
Item	Encroachments
RD 1001 Unit 2 - L/S - Prunning Piles	
cathom_f_20120912_102.JPG

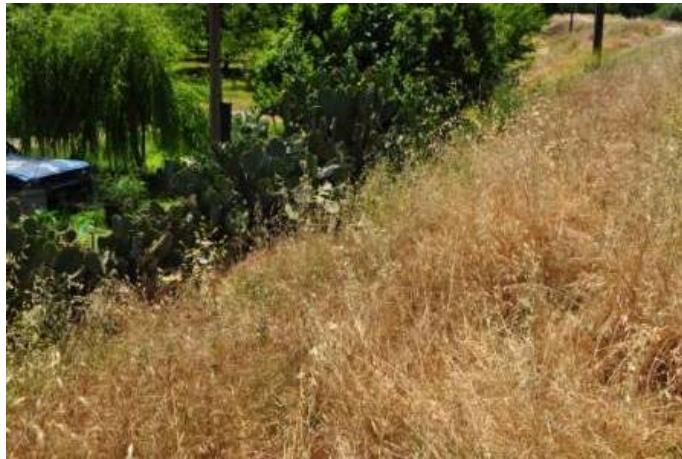
Levee Mile Report Line	6
Start Levee Mile	0.67
End Levee Mile	0.67
Location	Land Side
Category	Earthen Levee
Item	Vegetation
RD 1001 Unit 2 - L/S - Landscaping - Cactus and fruit trees	
cathom_f_20120912_103.JPG

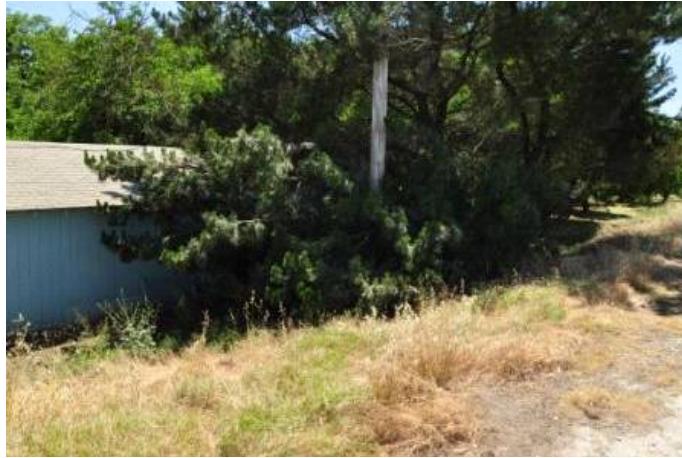
Levee Mile Report Line	7
Start Levee Mile	0.78
End Levee Mile	0.78
Location	Land Side
Category	Earthen Levee
Item	Trim / Thin Trees
RD 1001 Unit 2 - L/S - Trim Tree	
cathom_f_20120912_105.JPG

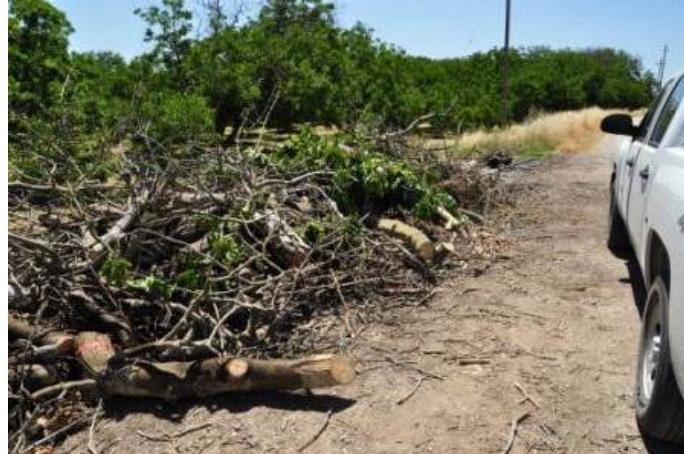
Levee Mile Report Line	8
Start Levee Mile	0.81
End Levee Mile	0.81
Location	Land Side
Category	Earthen Levee
Item	Encroachments
RD 1001 Unit 2 - L/S - Prunning Piles	
cathom_f_20120912_099.JPG

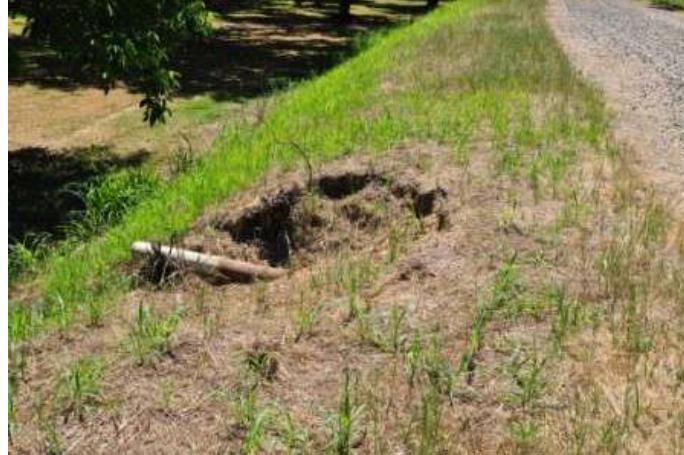
Levee Mile Report Line	10
Start Levee Mile	1.34
End Levee Mile	1.34
Location	Land Side
Category	Earthen Levee
Item	Erosion / Bank Caving
RD 1001 Unit 2 - L/S -Erosion @ pipe.	
cathom_f_20120912_107.JPG

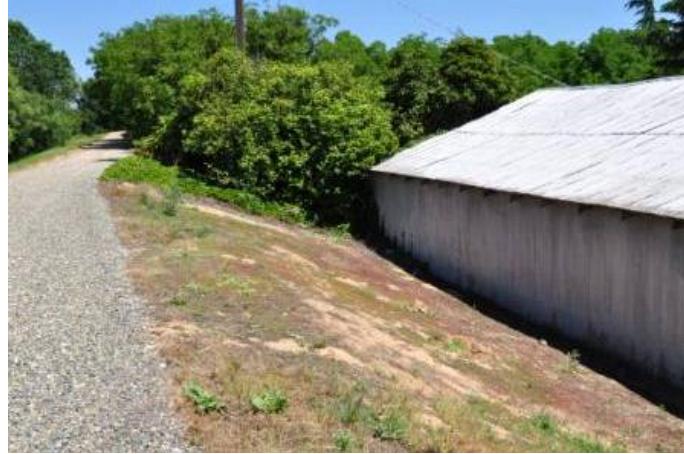
Levee Mile Report Line	12
Start Levee Mile	1.77
End Levee Mile	1.77
Location	Land Side
Category	Earthen Levee
Item	Vegetation
RD 1001 Unit 2 - L/S -Landscaping - Trees	
cathom_f_20120912_100.JPG

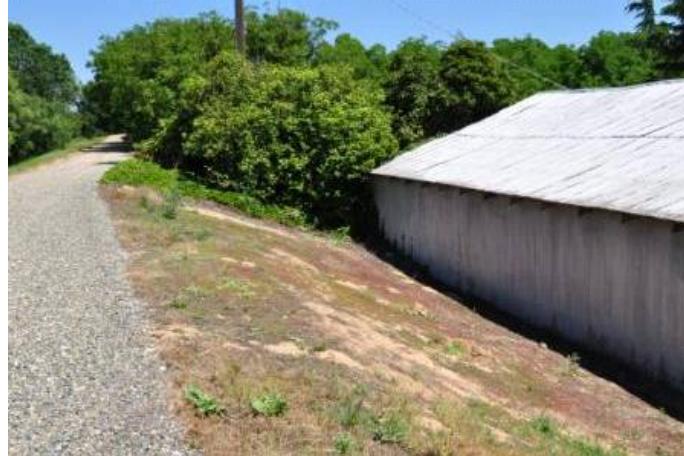
Levee Mile Report Line	13
Start Levee Mile	1.78
End Levee Mile	1.78
Location	Land Side
Category	Earthen Levee
Item	Encroachments
RD 1001 Unit 2 - L/S -Building @ toe.	
cathom_f_20120912_101.JPG

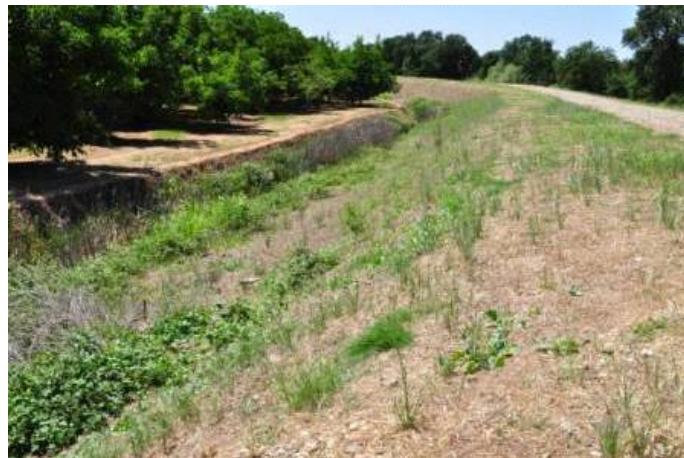
Levee Mile Report Line	15
Start Levee Mile	2.32
End Levee Mile	2.55
Location	Land Side
Category	Earthen Levee
Item	Encroachments
RD 1001 Unit 2 - L/S - Drainage Ditch @ toe.	
cathom_f_20120912_108.JPG

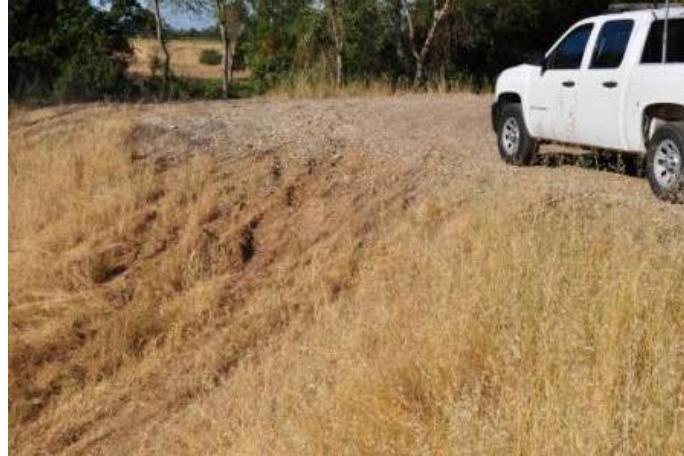
Levee Mile Report Line	2
Start Levee Mile	0.10
End Levee Mile	0.10
Location	Land Side
Category	Earthen Levee
Item	Slope Stability
RD 1001 Unit 3 - Slope damage - vehicle	
cathom_f_20120912_125.JPG

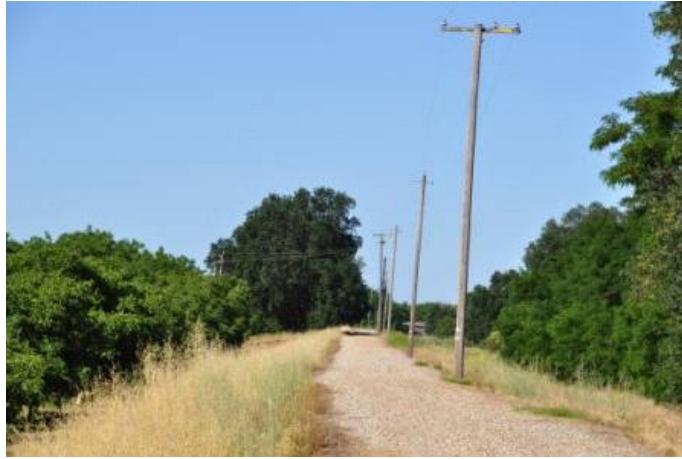
Levee Mile Report Line	7
Start Levee Mile	1.21
End Levee Mile	1.77
Location	Water Side
Category	Earthen Levee
Item	Encroachments
RD 1001 Unit 3 - Power Poles along W/S shoulder.	
cathom_f_20120912_109.JPG

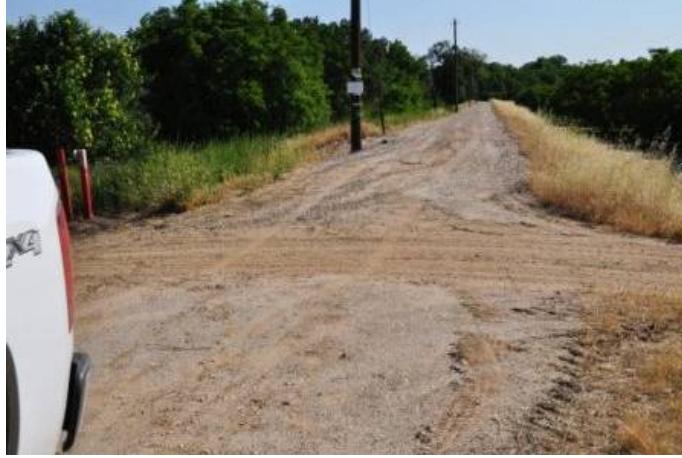
Levee Mile Report Line	8
Start Levee Mile	1.47
End Levee Mile	1.47
Location	Water Side
Category	Earthen Levee
Item	Slope Stability
RD 1001 Unit 3 - Crown subsidence due to vehicle traffic.	
cathom_f_20120912_110.JPG

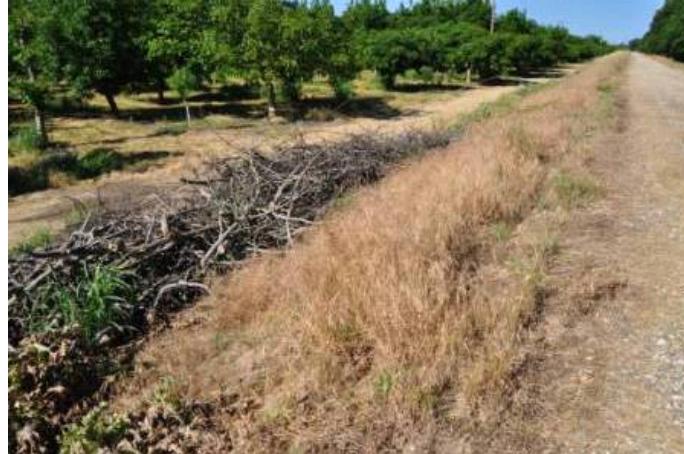
Levee Mile Report Line	9
Start Levee Mile	2.96
End Levee Mile	3.32
Location	Land Side
Category	Earthen Levee
Item	Encroachments
RD 1001 Unit 3 - Pruning Pile	
cathom_f_20120912_127.JPG

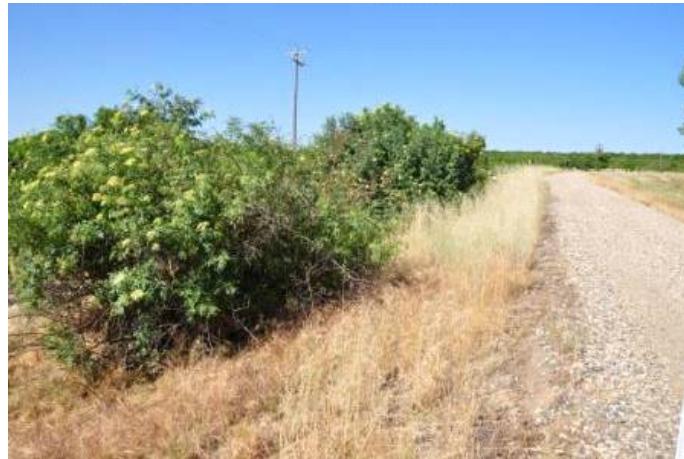
Levee Mile Report Line	10
Start Levee Mile	3.54
End Levee Mile	3.54
Location	Land Side
Category	Earthen Levee
Item	Vegetation
RD 1001 Unit 3 - L/S slope -Elderberries	
cathom_f_20120912_131.JPG

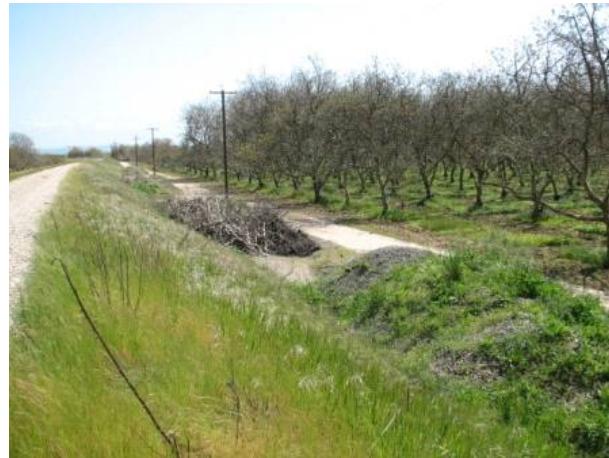
Levee Mile Report Line	11
Start Levee Mile	3.80
End Levee Mile	3.96
Location	Land Side
Category	Earthen Levee
Item	Encroachments
Levee mile 3.80, this photo is looking at the debris on the landside slope and toe.	
cathom_f_20120912_112.jpg

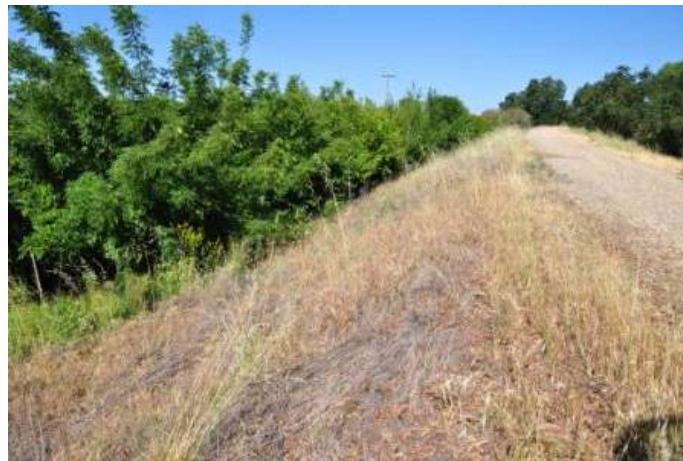
Levee Mile Report Line	14
Start Levee Mile	4.12
End Levee Mile	4.20
Location	Land Side
Category	Earthen Levee
Item	Vegetation
RD 1001 Unit 3 - L/S slope - Landscaping	
cathom_f_20120912_116.JPG

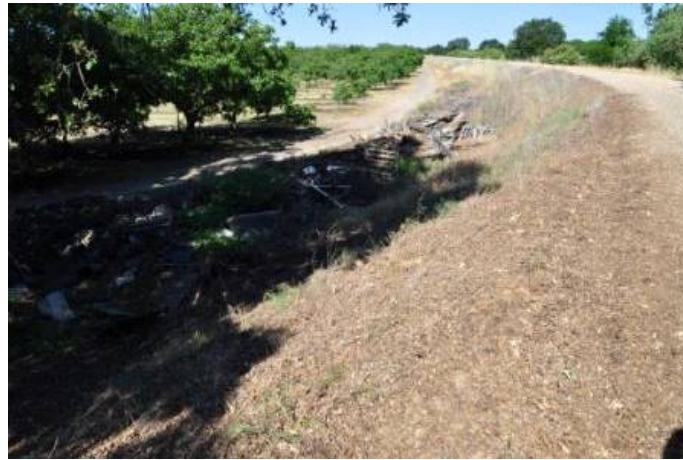
Levee Mile Report Line	16
Start Levee Mile	4.29
End Levee Mile	4.29
Location	Land Side
Category	Earthen Levee
Item	Encroachments
RD 1001 Unit 3 - L/S slope - Debris	
cathom_f_20120912_118.JPG

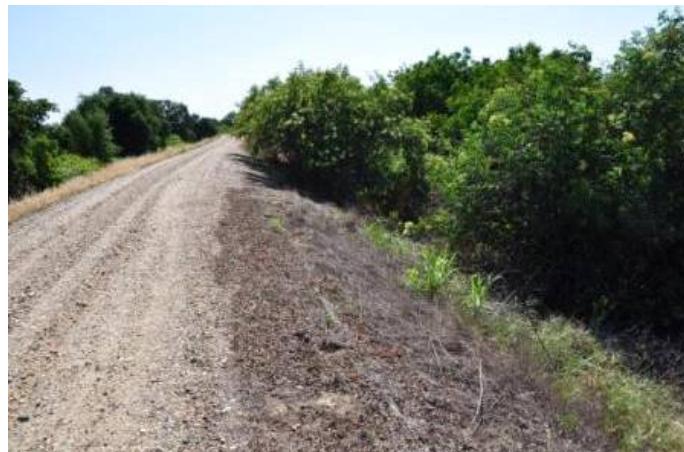
Levee Mile Report Line	18
Start Levee Mile	4.68
End Levee Mile	4.68
Location	Land Side
Category	Earthen Levee
Item	Vegetation
RD 1001 Unit 3 - W/S slope -Elderberries	
cathom_f_20120912_128.JPG

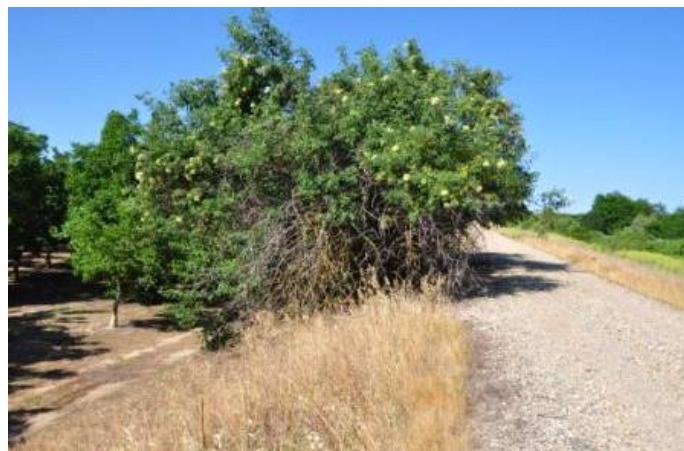
Levee Mile Report Line	20
Start Levee Mile	4.85
End Levee Mile	4.85
Location	Land Side
Category	Earthen Levee
Item	Vegetation
RD 1001 Unit 3 - L/S slope -Elderberries	
cathom_f_20120912_132.JPG

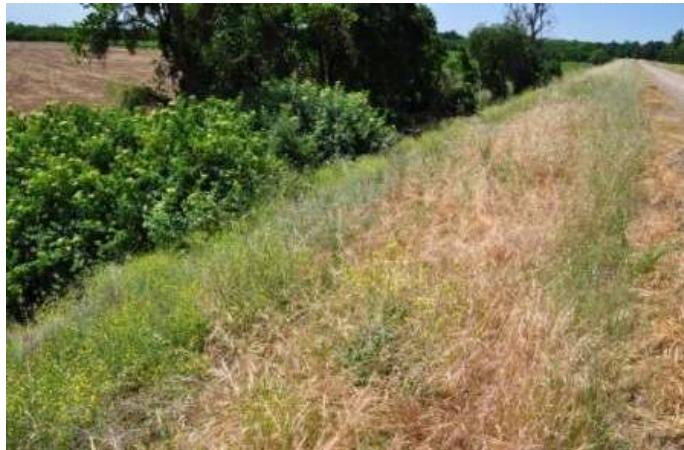
Levee Mile Report Line	32
Start Levee Mile	12.24
End Levee Mile	12.24
Location	Land Side
Category	Earthen Levee
Item	Vegetation
RD 1001 Unit 3 - L/S slope -Elderberries @ toe.	
cathom_f_20120912_124.JPG

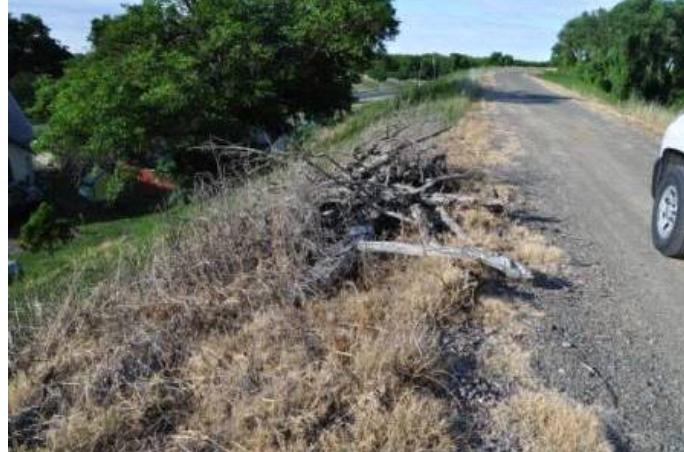
Levee Mile Report Line	6
Start Levee Mile	2.88
End Levee Mile	2.88
Location	Water Side
Category	Earthen Levee
Item	Encroachments
RD 1001 Unit 4 - L/S slope - Limb/Wood Pile.	
cathom_f_20120912_176.JPG

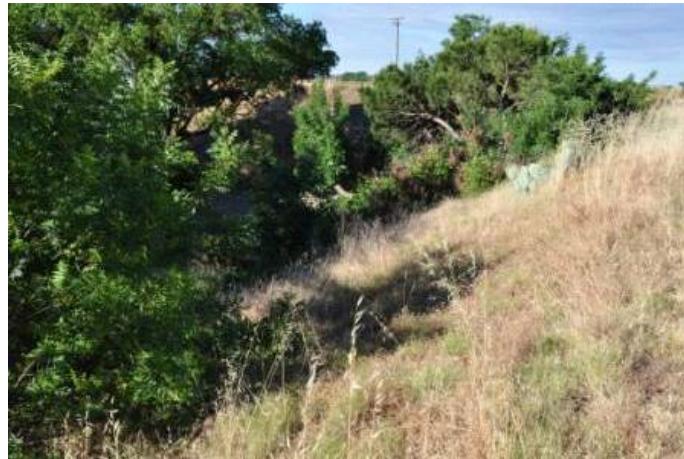
Levee Mile Report Line	7
Start Levee Mile	3.21
End Levee Mile	3.23
Location	Land Side
Category	Earthen Levee
Item	Vegetation
RD 1001 Unit 4 - L/S slope - Landscaping/Trees	
cathom_f_20120912_172.JPG

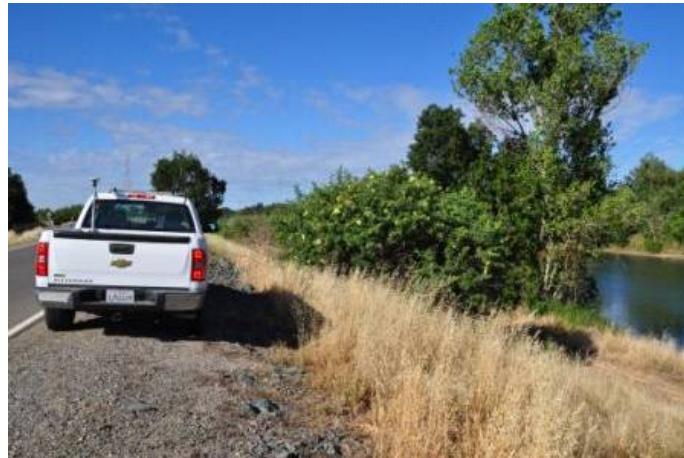
Levee Mile Report Line	8
Start Levee Mile	5.60
End Levee Mile	5.60
Location	Water Side
Category	Earthen Levee
Item	Vegetation
RD 1001 Unit 4 - W/S slope - Elderberries	
cathom_f_20120912_177.JPG

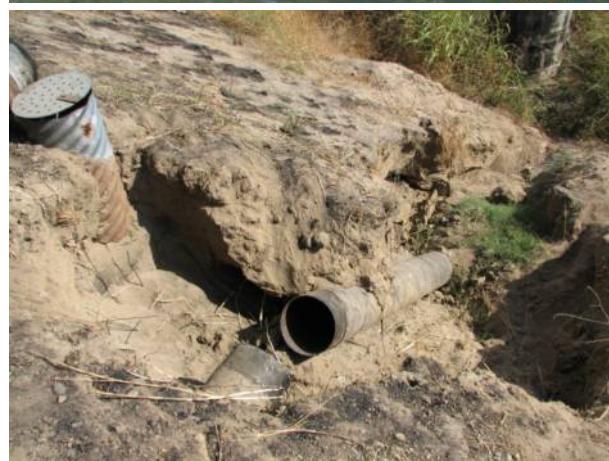
Levee Mile Report Line	15
Start Levee Mile	6.83
End Levee Mile	6.83
Location	Land Side
Category	Earthen Levee
Item	Encroachments

Levee mile 6.83, this pipe is being repaired.

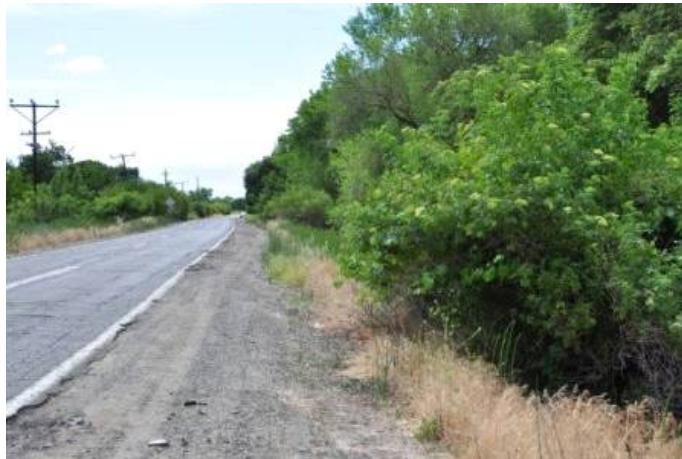
Levee Mile Report Line	27
Start Levee Mile	12.74
End Levee Mile	13.22
Location	Land Side
Category	Earthen Levee
Item	Vegetation
RD 1001 Unit 4 - W/S slope - Elderberries	
cathom_f_20120912_167.JPG

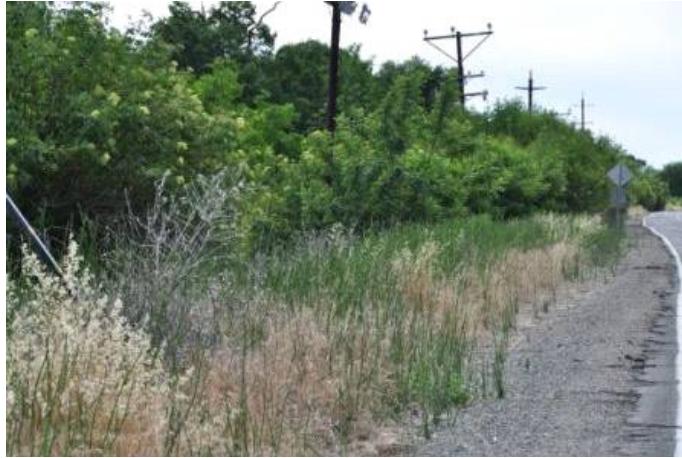
Levee Mile Report Line	28
Start Levee Mile	12.76
End Levee Mile	13.21
Location	Water Side
Category	Earthen Levee
Item	Vegetation
RD 1001 Unit 4 - W/S slope - Elderberries	
cathom_f_20120912_142.JPG

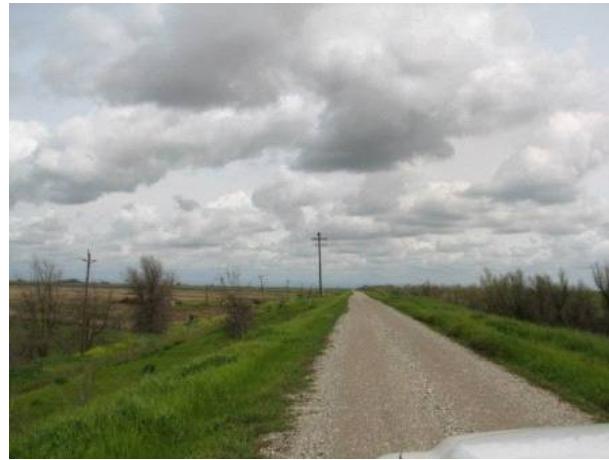
Levee Mile Report Line	6
Start Levee Mile	1.15
End Levee Mile	1.15
Location	Land Side
Category	Earthen Levee
Item	Encroachments
Pole on land side shoulder levee mile 1.15.	
cathom_f_20120912_185.jpg

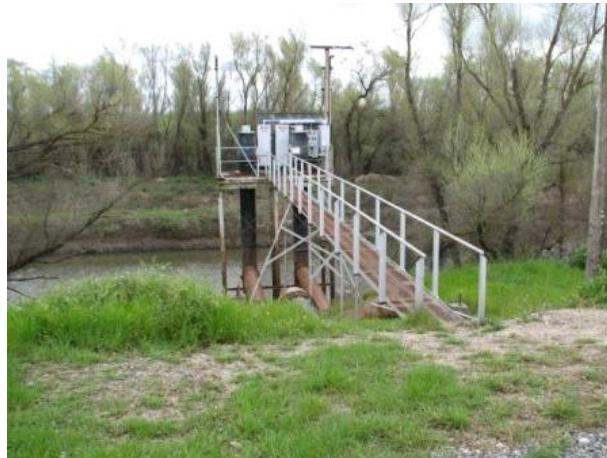
Levee Mile Report Line	9
Start Levee Mile	3.69
End Levee Mile	3.69
Location	Water Side
Category	Earthen Levee
Item	Encroachments
Pump water side levee mile 3.69.	
cathom_f_20120912_188.jpg

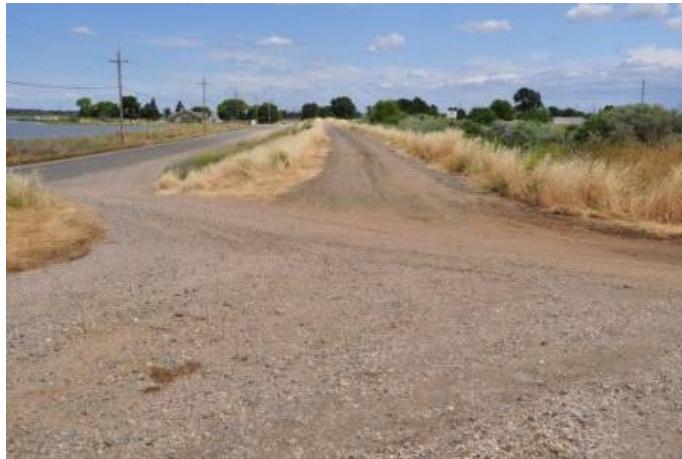
Levee Mile Report Line	11
Start Levee Mile	4.05
End Levee Mile	4.05
Location	Crown
Category	Earthen Levee
Item	Slope Stability
RD 1001 Unit 6 - Levee Crown - Subsidence due to vehicle traffic.	
cathom_f_20120912_196.JPG
